# MANAGEMENT OF GULLY EROSION IN AKKO LOCAL GOVERNMENT AREA, GOMBE STATE: A PHYSICAL PLANNING PERSPECTIVE

**Abstract:** *This paper is focused on making a critical analysis of the gully erosion problem in Akko local government area. The problems of gully erosion in Akko L.G.A have led to the loss of several lives and properties over the years and will persist if nothing is done to mitigate the situation. Data was collected to show the magnitude and the extent of the gully problem in Akko L.G.A. The study showed that, apart from the natural factors such as rainfall, the nature of the soil and the topography of Akko L.G.A., human factors in the use of land, especially in prone areas, also contribute to a great extent. An analytical method was also used to show the increase in gully erosion, and arithmetic progression was used to establish a trend for forecasting future occurrences and devastation. Based on the identified problems caused by gully erosion in Akko L.G.A., recommendations are made to manage and reduce the effects of gully erosion problems in Akko L.G.A. within the framework of the present and the future.*

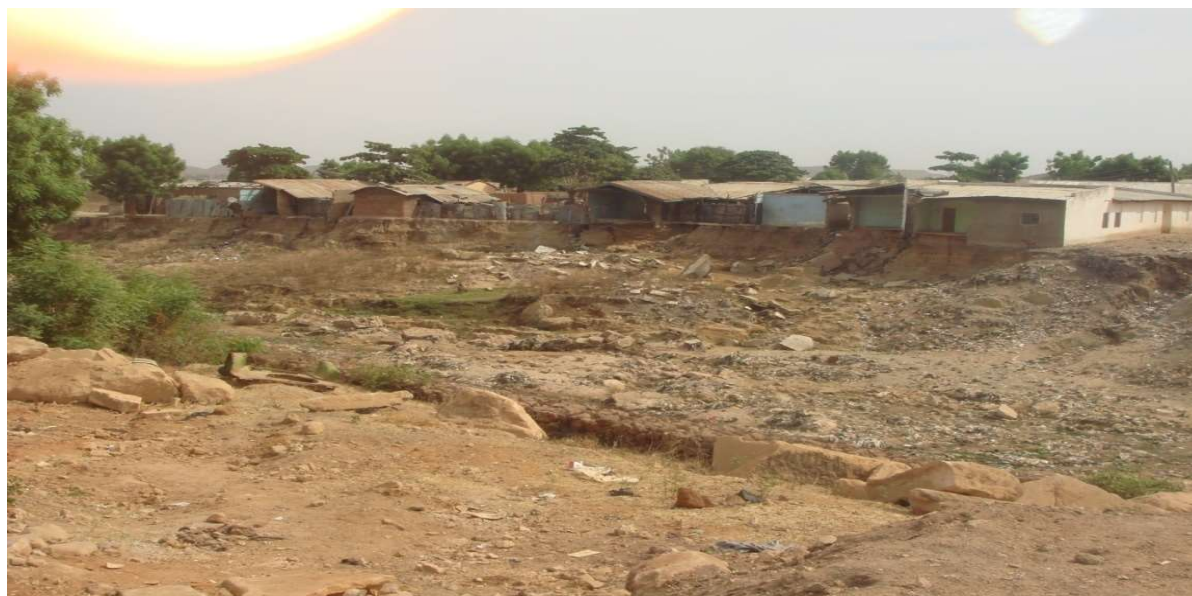
53 dwellings have been entirely lost to gully erosion. Approximately 203 dwellings sustained significant damage, while the others remain unscathed but are at risk due to the ongoing expansion of the gullies.

Plate 1: Gully threatening houses in Kumo

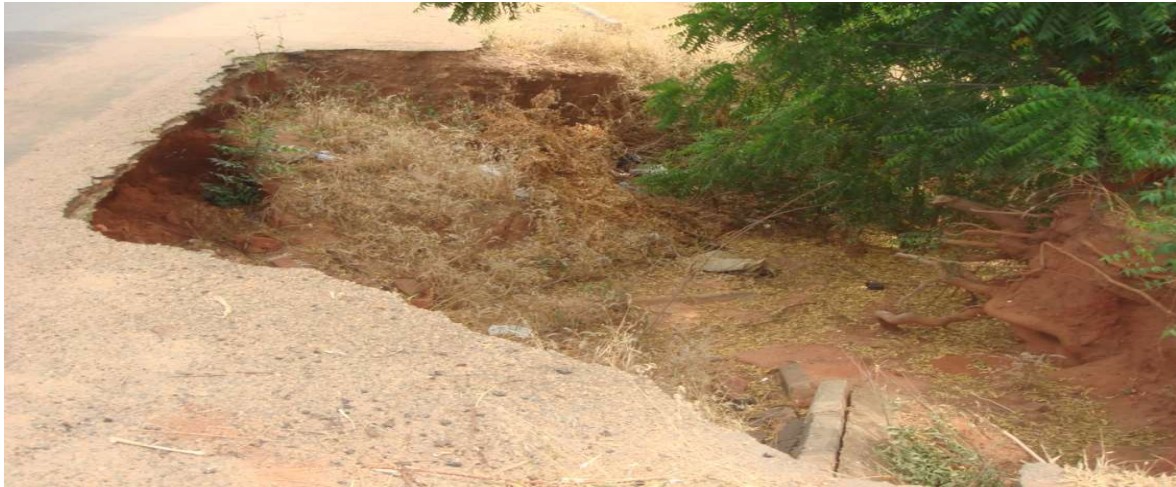
Plate 2: Gully undercutting regional road in Gona

Circulation is occasionally obstructed when walkways are undermined and disjointed. In some instances, the gullies form near the peripheries of villages, hindering expansion. According to the table, roads, culverts, and drainage systems incur the most financial damage impact, accounting for 57.07%. Buildings experience an impact of 32.44%, whilst farms and grazing areas endure the least at 10.49%.

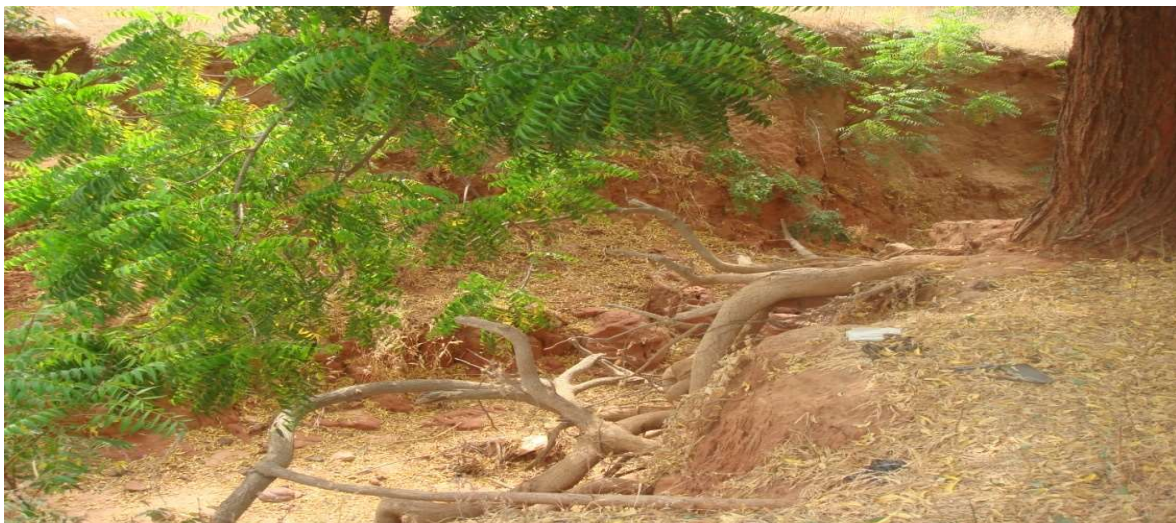
Plate 3: Gully traversing farmland in Pindiga
